INDEPENDENT ENVIRONMENTAL AUDIT REPORT

Site B4A, 37 Friendship Road, Port Botany, NSW 2036

Vopak Terminals Australia Pty Ltd 3 May 2022 21292 R1

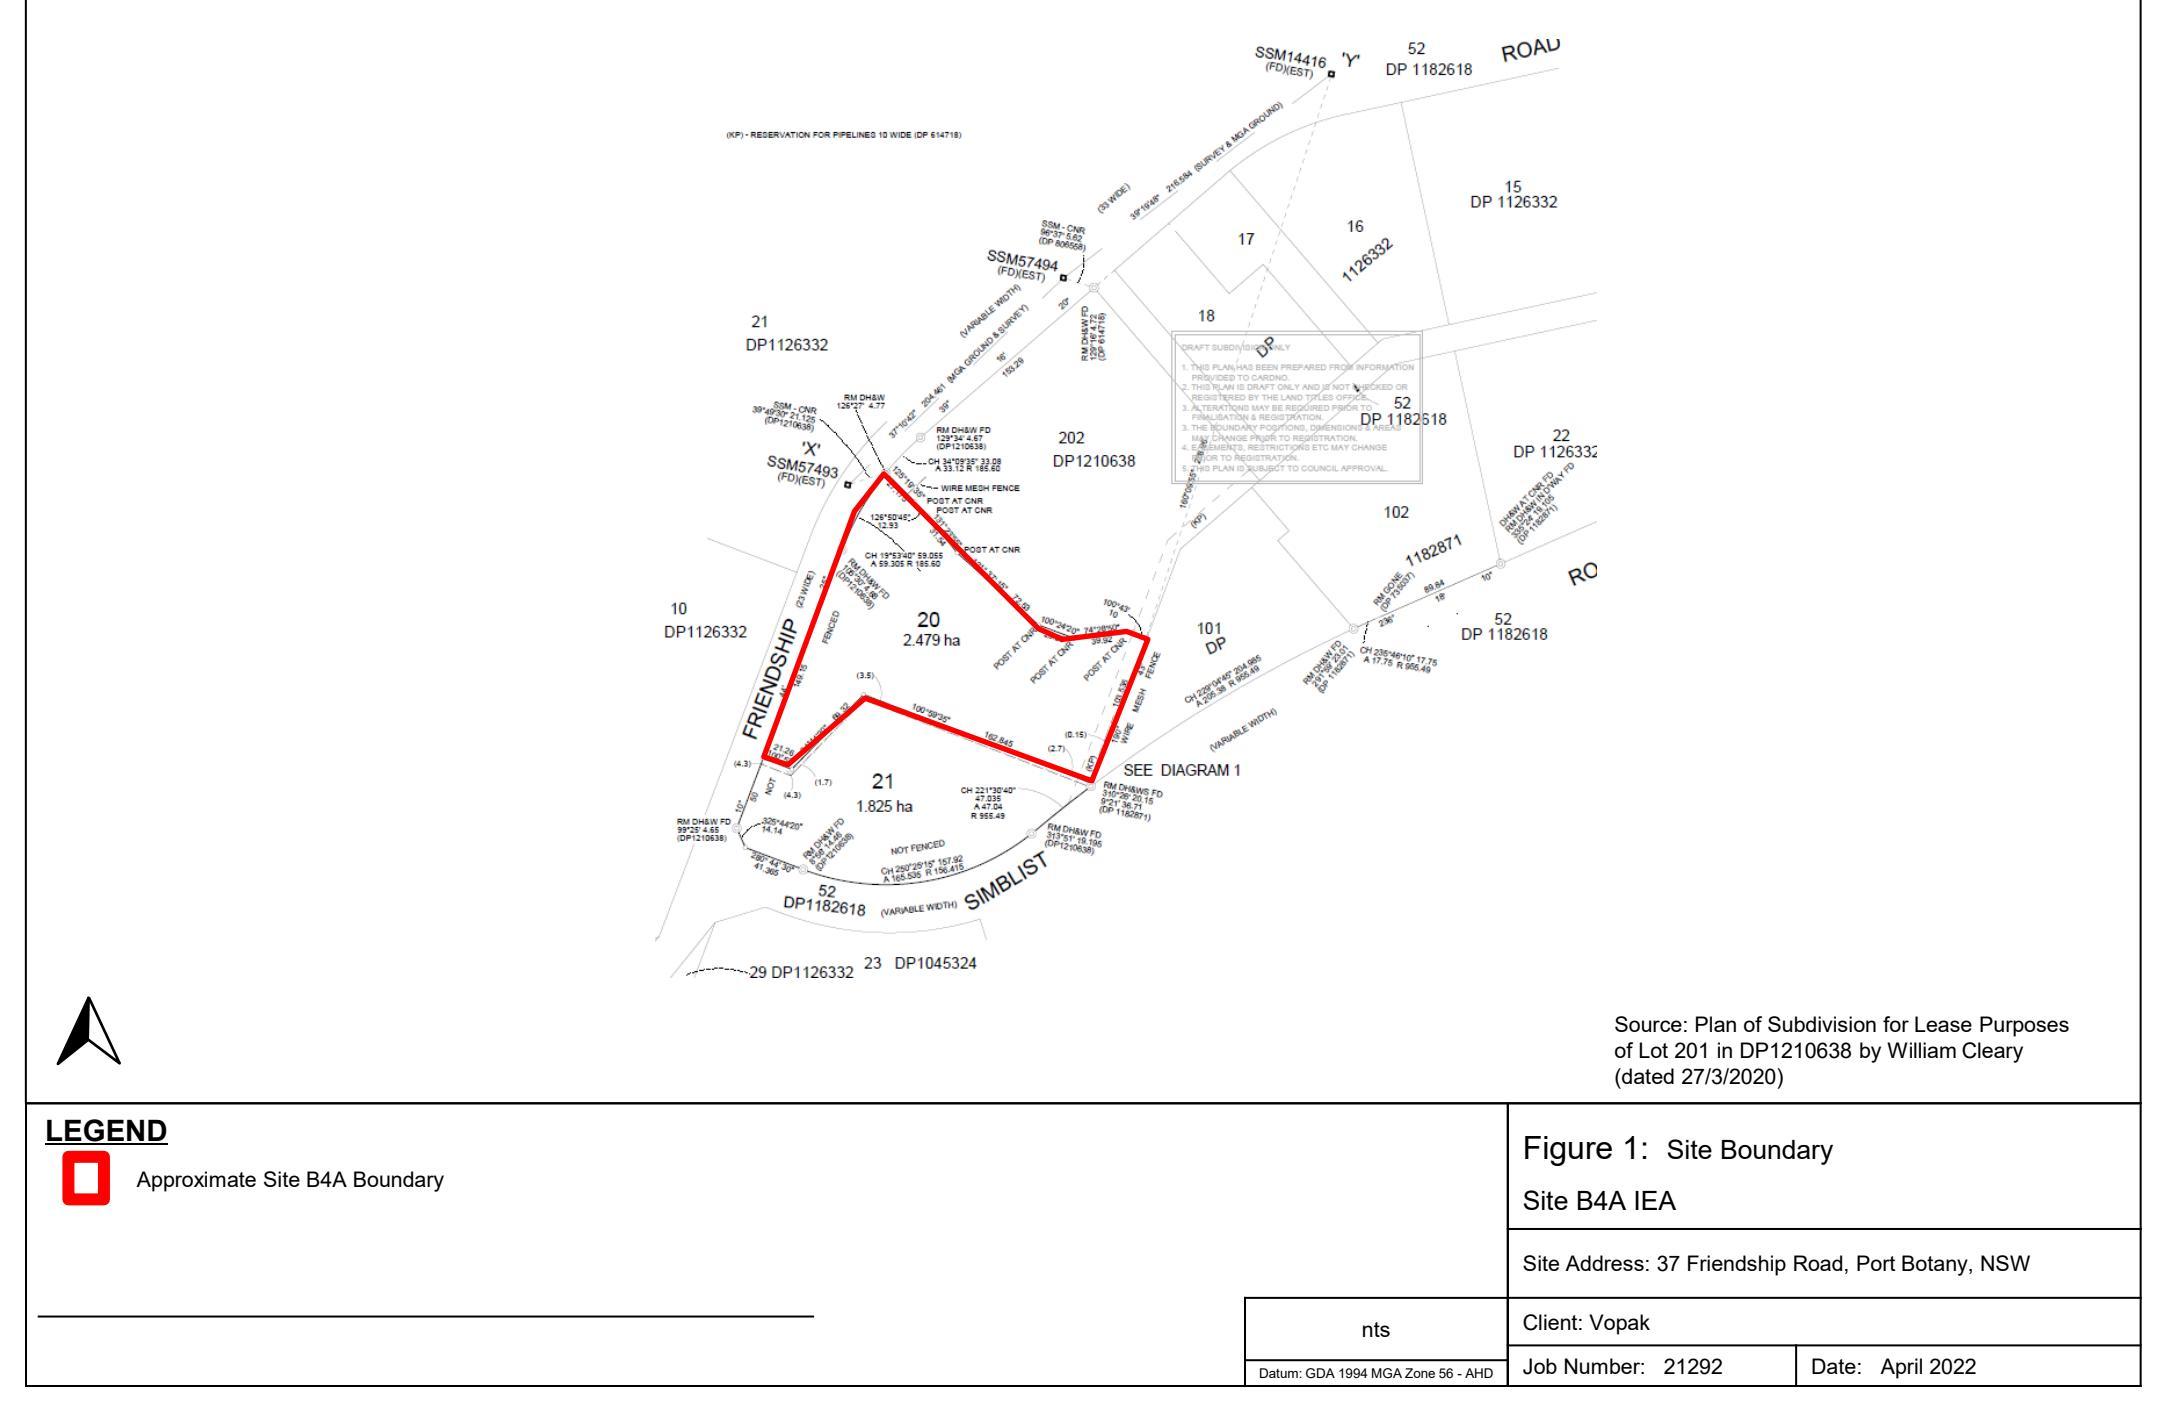
Appendix A Figures

- Physical boundary: The site is 23,500m² and located within Lot 20 DP1272410 (formerly Lot 201 in DP1210638). The boundary of this Audit is shown in the site plan included in Appendix A. The site is currently an operational facility. The Audit also included observations of the general surrounding area.
- The temporal boundary of the audit is for the duration of the construction and operational phases. It is noted that construction had been completed at the time of commencement of the Audit. Based on the advice provided by DP&E in an email dated 16 March 2022, given that no audit was conducted during the construction phase, the current audit must include the construction phase as well.
